Investigations of Existing
Pressure Sewer Systems

EPA/600/2-85/051
April 1985

Joseph W. Rezek
Ivan A. Cooper
Rezek, Henry, Meisenheimer and Gende, Inc.
Libertyville, Illinois 60048

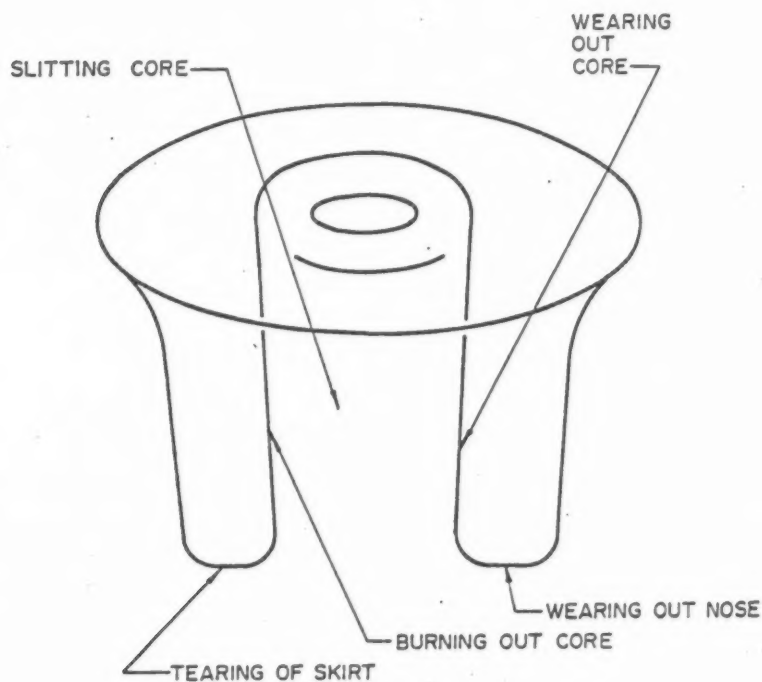
Figure 31. Boot failure mode.

Figure 31 shows the five basic modes of boot failure, causes of which are explained below. Tearing of the rubber skirt can occur during short and periodic dry running of the pump stator. This can be caused by failure of the pressure switch to shut down pump operation after the chamber has been evacuated. If the pump runs continuously when dry, then the boot core can burn out.

Another common failure mode occurs when the boot core is worn out. This occurs when abrasives such as sand, plaster or egg shells routinely enter the pump chamber. This problem can be minimized by reducing the presence of abrasives through instruction of householders, installation of grit traps, or improving the durability of the boot.
